DEPRECIATION REPORT UPDATE

EAGLE RIDGE ESTATES

1255 WAIN ROAD, NORTH SAANICH

October 29, 2025

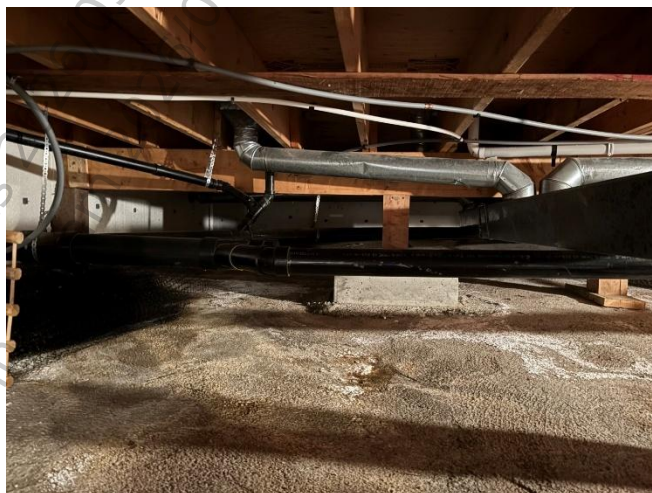
Photo 2: Typical crawlspace with limited clearance.

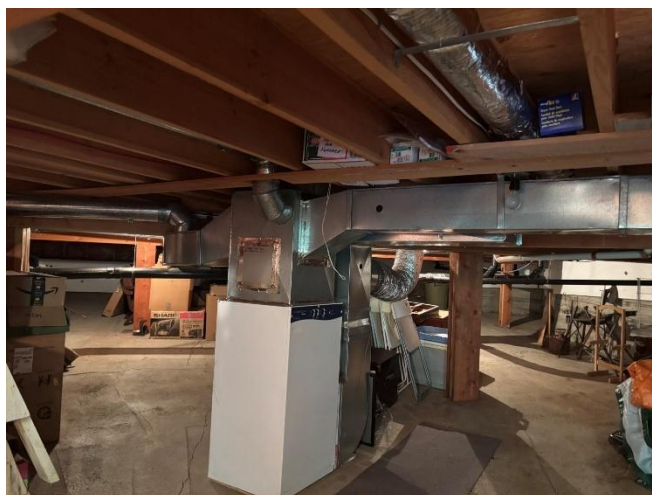
Photo 3: Typical crawlspace with additional clearance.

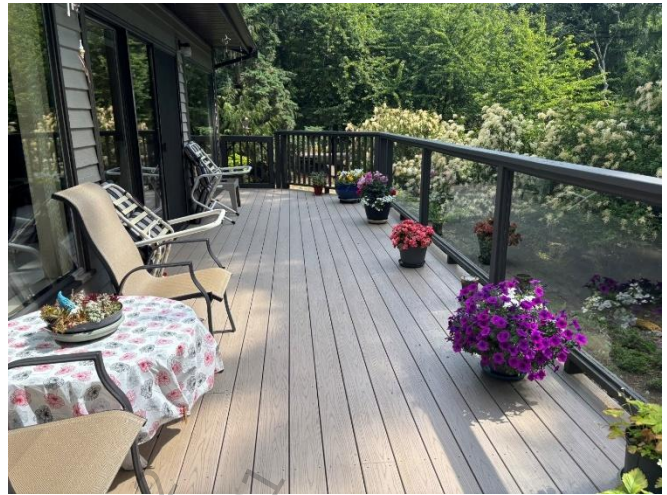
Photo 4: Typical main deck.

A recent Deck Inspection Summary Report prepared by Pro Deck Ltd. identified various main deck deficiencies and provided a budget to complete the recommended repairs. We have incorporated the repair budget as indicated in the Strata's planned capital expense budget for 2025. After this, we have provided a biennial allowance to complete further main deck repairs on an isolated, as-needed basis.

We have budgeted to replace the composite plank decking on all main decks at the end of their expected service life. The related project expenditure shown in the Capital Projects table shows the cost on a per year basis. We have also budgeted for evaluating the condition of the main decks prior to replacing the decking.

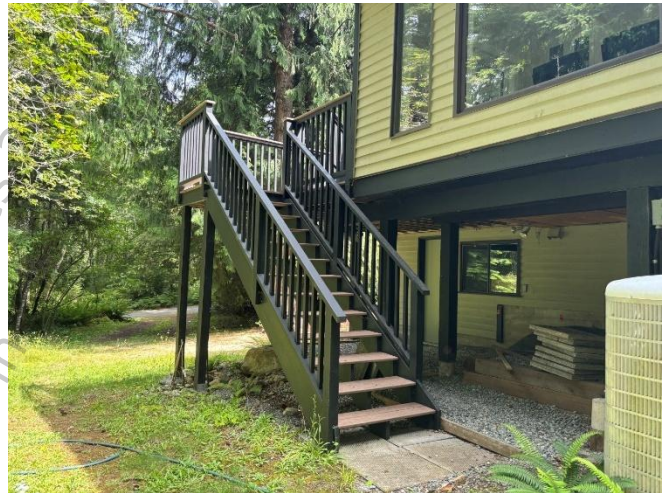
Photo 5: Typical staircase providing access onto main deck and supporting wood posts.

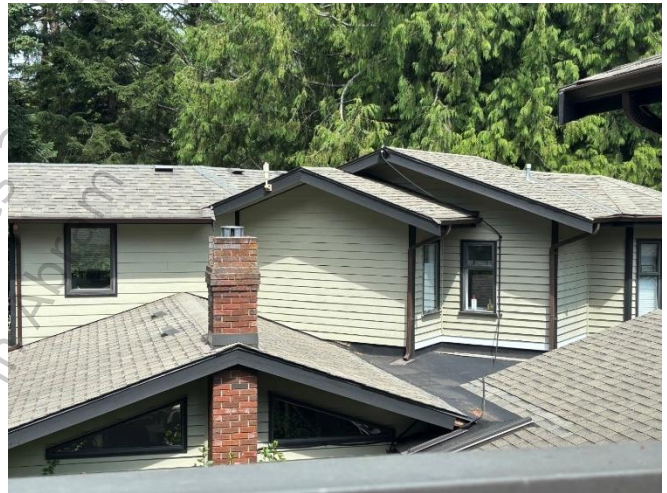
The exterior walls are primarily clad with painted cedar siding. “Hardie Plank” fibre cement board has been used in some locations to replace sun damaged original siding. Hardie Plank has also been used in place of cedar on newer main and second floor additions. Walls between the townhouse units are stucco cladding. The chimneys are clad in brick.

Photo 7: New fibre cement lap siding and typical brick chimney.

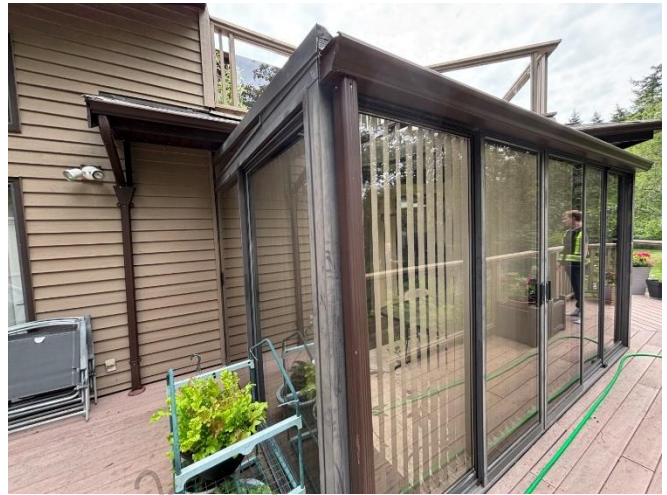
Photo 14: Typical solarium.

Eventually most sloped glazing systems need a major overhaul (or replacement). Based on the age of the systems and the reported performance, we have provided an allowance for a major overhaul of the systems within the report term. The related project expenditure shown in the Capital Projects table shows the cost on a per year basis.

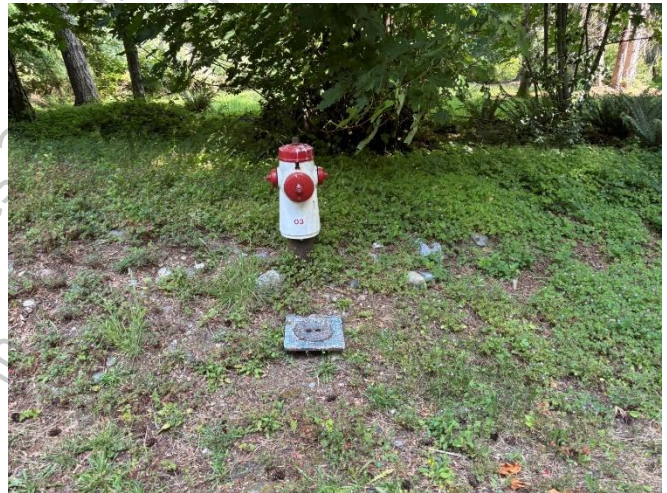
Although fire hydrants can last over 100 years, the gaskets and seals typically harden and fail after 50-60 years, often requiring replacement of the hydrants. If this happens, the hydrants will need to be replaced. That said, some seals can last longer than others, and there are some 100-year-old hydrants still in service. We do not expect that any hydrants will require general replacement within the report term. However, this will need to be added as part of future updates to this report.

Photo 20: Typical fire hydrant.

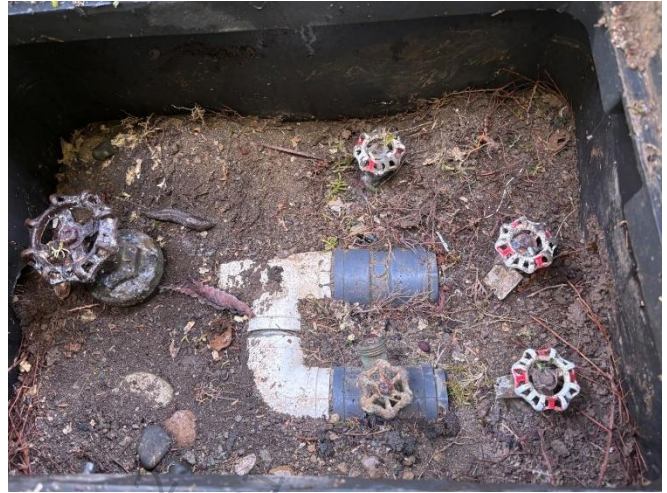
Photo 32: Water line splitting to supply domestic water to each unit within a pod.

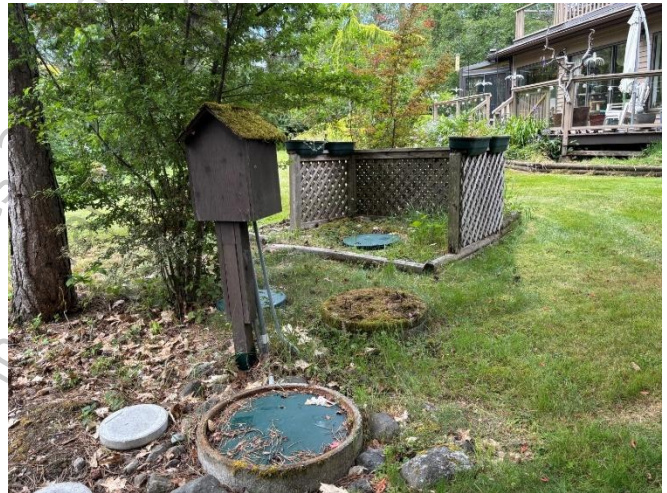
Photo 35: Typical septic tanks.

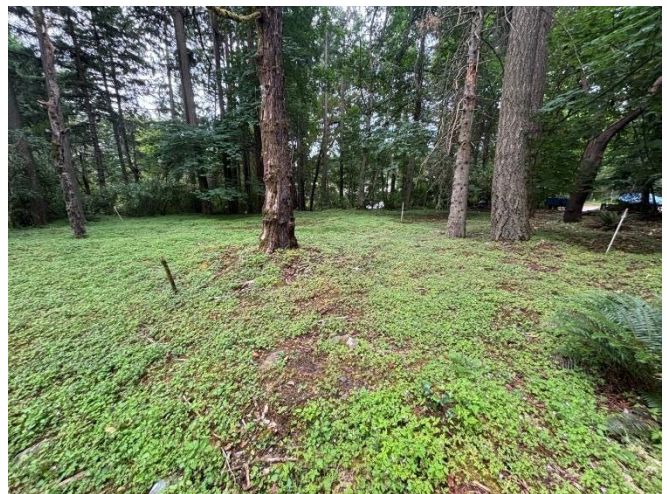
Photo 36: Typical septic drainage field.
