DEPRECIATION REPORT UPDATE

EAGLE RIDGE ESTATES

1255 WAIN ROAD, NORTH SAANICH

October 29, 2025

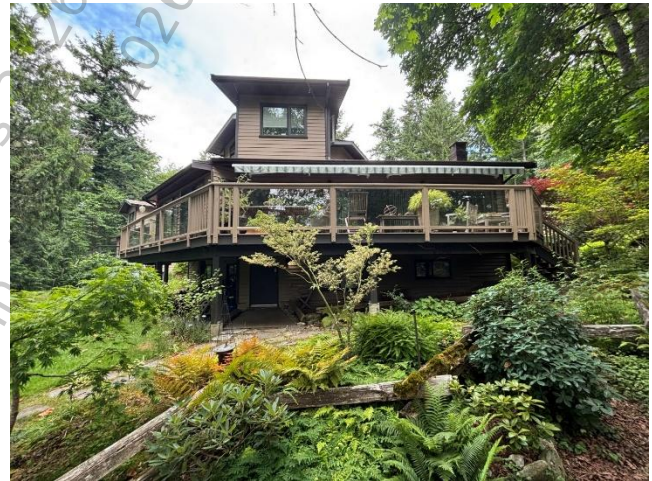
Photo 2: Typical main deck.

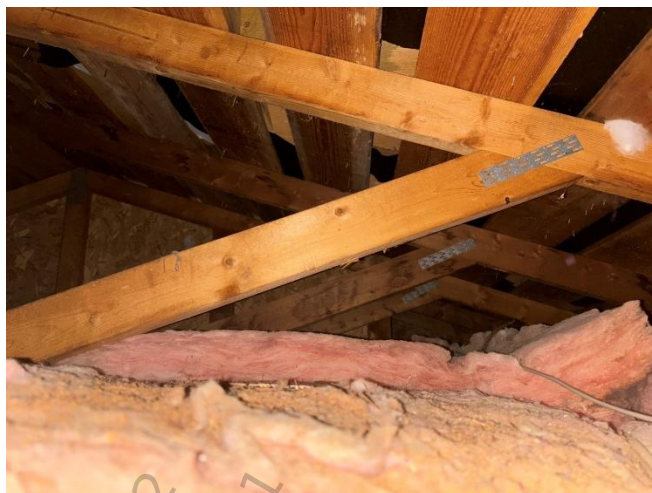
Photo 1: Typical roof structure.

Most of the structural components are concealed from view. We saw no evidence of unusual settlement, displacement or structural cracking in the areas reviewed.

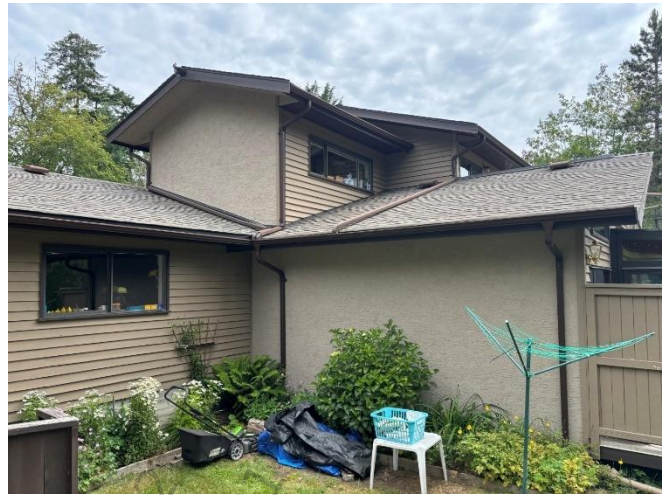
We were not made aware of any reports or evidence of active water leakage through the exterior walls.

Photo 6: Typical wood siding and stucco cladding.

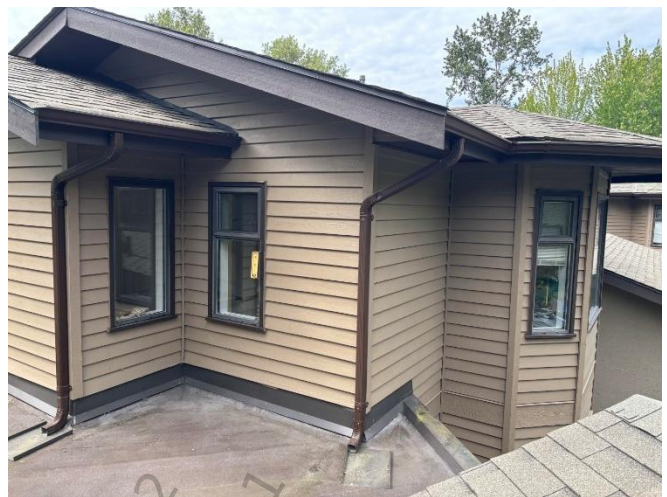
We were not made aware of any reports of water or excessive air leakage through the windows or balconies and roof deck doors. We understand that the Strata currently repairs and maintains these assemblies out of operating budgets, including replacing failed IGUs.

Photo 9: Typical exterior windows.

We have budgeted to evaluate the windows, main deck and upper deck doors as part of the BECA (see the *Exterior Walls* section of this report for further discussion and project budgets).

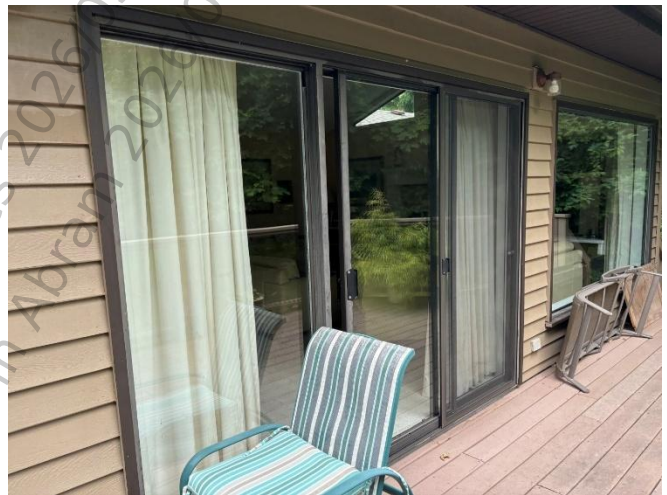
Photo 10: Typical sliding door at main deck.

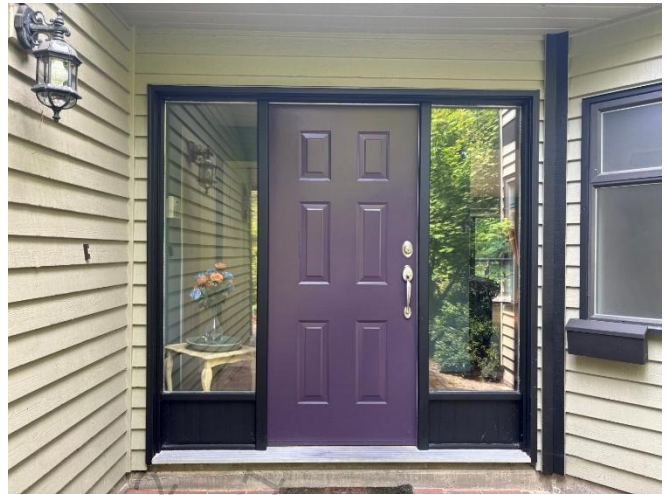
We were not made aware of any reports of water leakage through the doors and we did not see any evidence of water leakage in the areas reviewed. Where checked, the weatherstripping is in satisfactory condition.

Photo 11: Typical townhouse unit entrance door.

Based on the proactive maintenance approach by the Strata, we understand that Strata will continue to maintain the unit entrance doors rather than complete widespread replacement for these doors. We have provided an allowance to repair and/or replace these assemblies every five years.

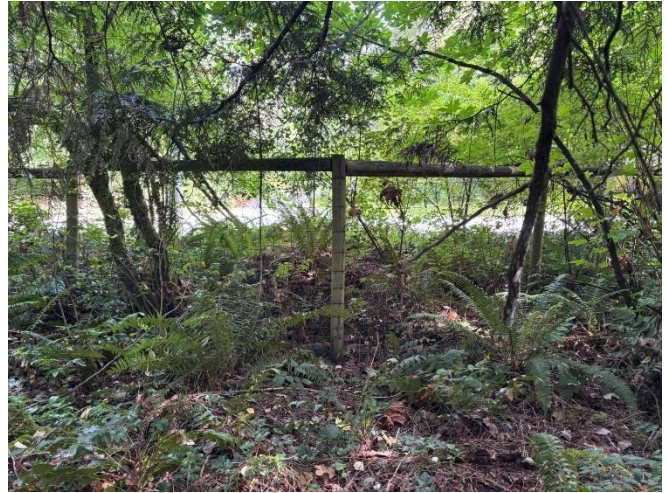
Photo 21: Typical perimeter fencing.

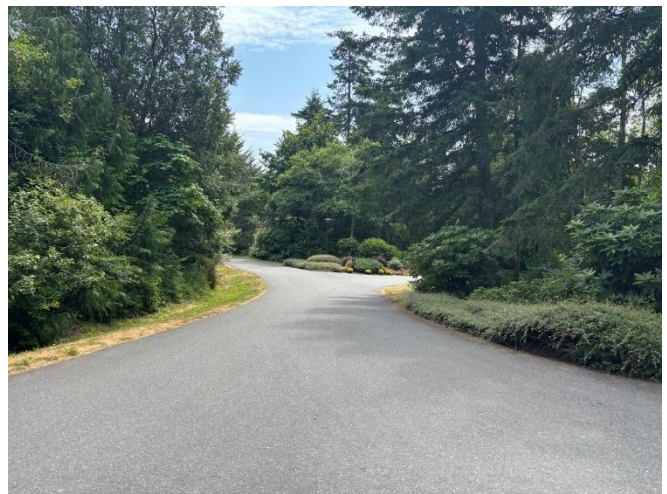
Photo 26: Typical roadway.

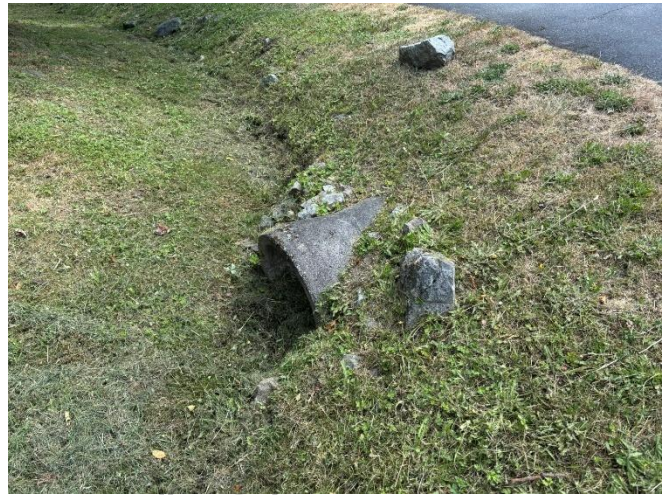
Photo 34: Typical ditch and culvert.

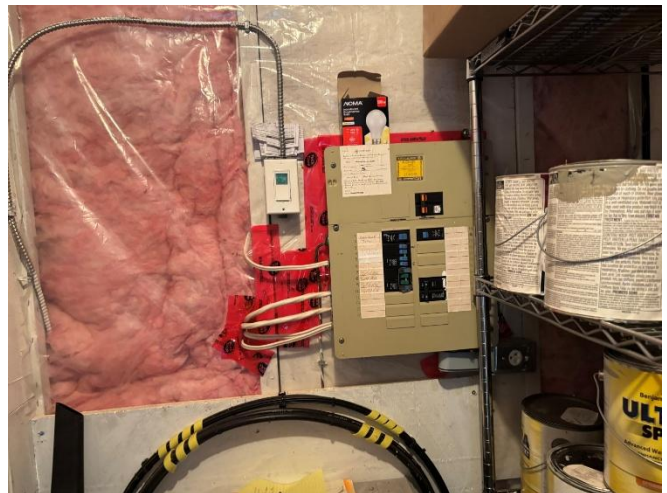
Photo 39: Electrical panel inside utility shed.

We recommend that all electrical panels and major equipment be thermally scanned every three years as a minimum. This is to identify hot spots that require repair. The scans and related required repairs (such as minor tightening, etc.) are assumed to be funded out of the operating budgets.

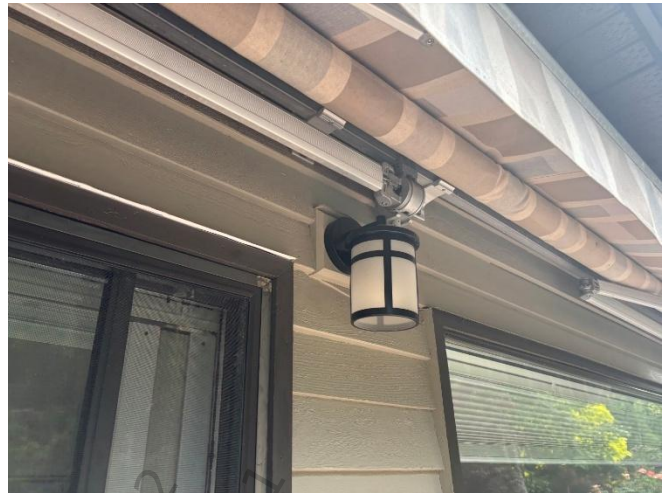
The light fixtures are in serviceable condition, where reviewed.

Photo 40: Typical wall-mounted light fixture at townhouse units.

We understand that owners have agreed to accept responsibility for repair and maintenance of the light fixtures mounted on the exterior walls of the townhouses, so no budgets have been included for their replacement.

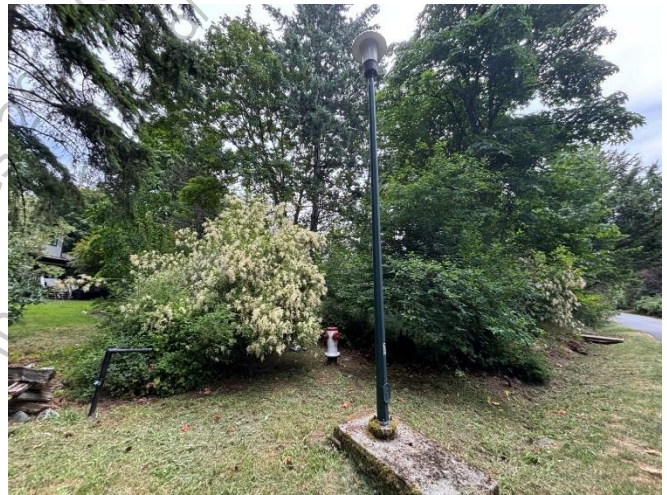
Photo 41: Typical pole-mounted fixture.

We assume that the replacement of the site and utility shed lighting will be completed on an as-needed basis as part of regular maintenance funded out of operating budgets.

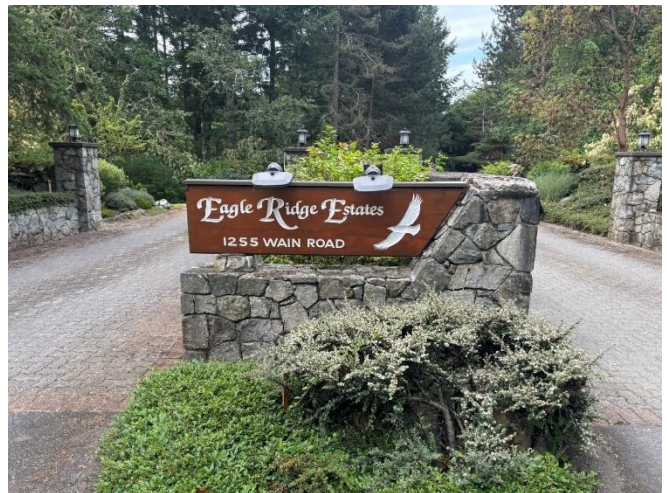
Photo 42: Complex entrance light fixtures.

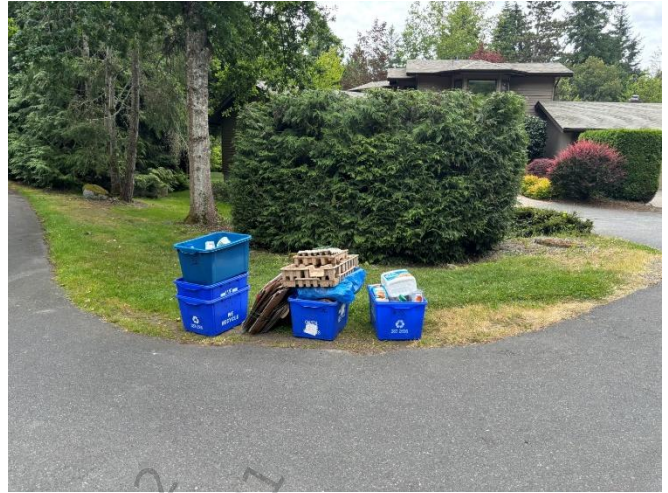
We assume that the garbage and recycling bins are the responsibility of the service contractors based on markings on the bins, so we have not budgeted for replacement of the bins.

Photo 43: Typical townhouse recycling containers

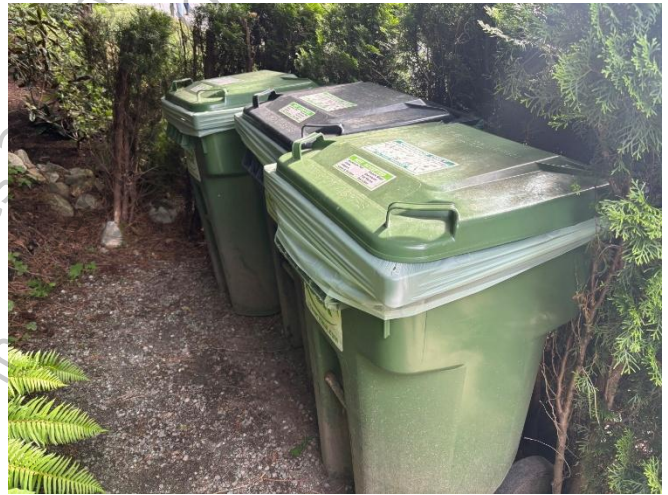
Photo 44: Organic waste containers.

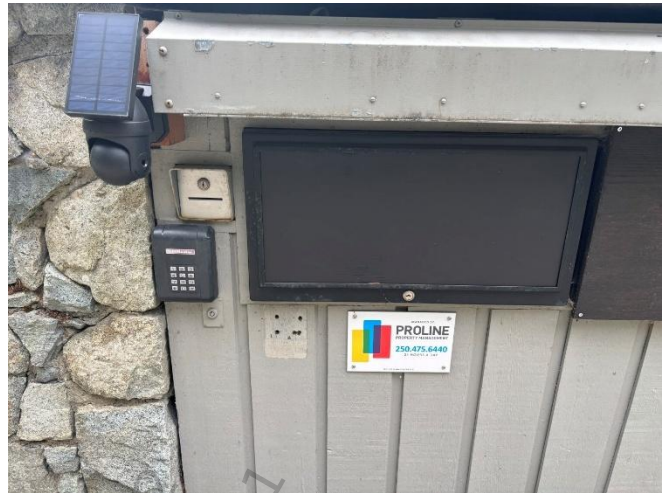
No problems were reported by the Strata. Local upgrades/replacements to the keypads are assumed to be managed from the operating budgets.

Photo 45: Enterphone and keypad at main entrance to complex.

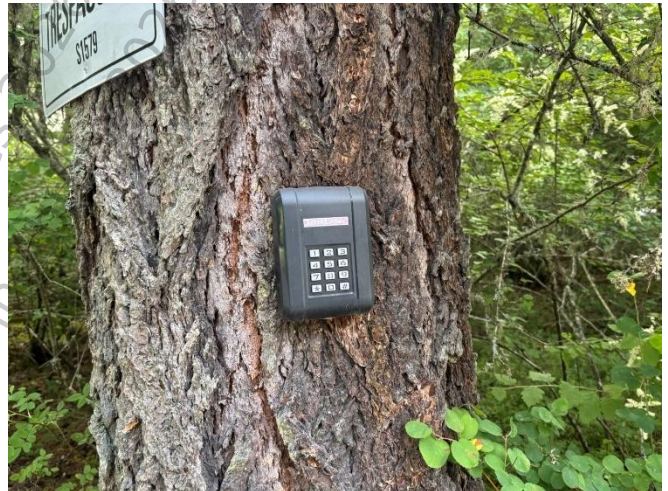
Photo 46: Keypad providing access to RV storage lot.
